Docket No. 217 – Development and Management Plan Inspection

Northeast Utilities Service Company Certificate of Environmental Compatibility and Public Need for the construction of a 345-kV electric transmission line and reconstruction of an existing 115-kV electric transmission line between Connecticut Light and Power Company's Plumtree Substation in Bethel, through the towns of Redding, Weston, and Wilton, and to the Norwalk Substation in Norwalk, Connecticut.

Date: April 12, 2006

Location: 115 kV Underground Route

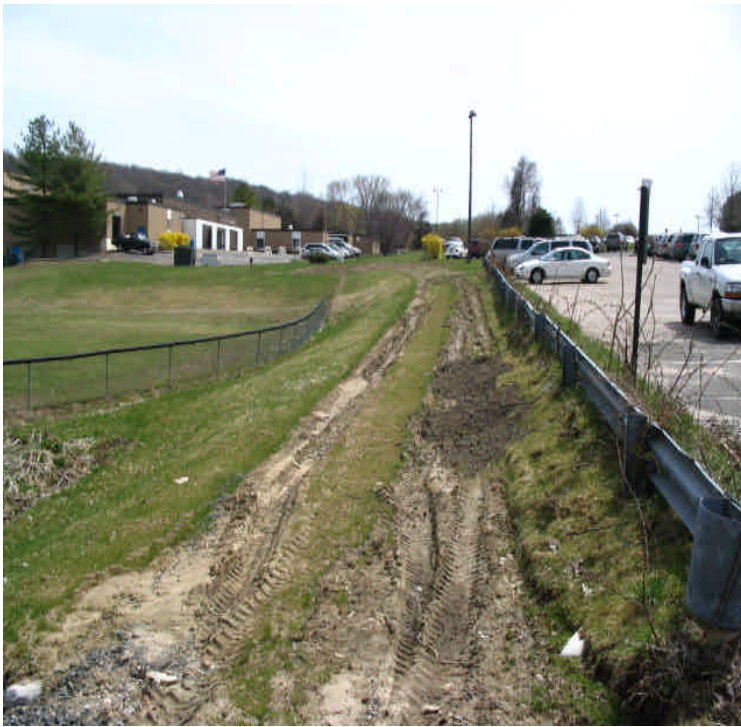
115kV (Bethel Ed. and Rt 58): Photo on the left shows the rut area remaining for restoration along the ROW near the north tower. Photo on the right shows roadside restoration near Putnam Park at a vault location. 4/12/06

- Hoyts Hill Transition Structure: Restoration noted. 4/12/06	-See EC section. 4/12/06	-N/A
	-Restoration noted. 4/12/06	- See EC section. 4/12/06	- N/A
	-Restoration noted. 4/12/06	-See EC section. 4/12/06	- N/A
	-Correction: stone in the ROW off Broad St. is actually in place for overhead work access. 4/12/06	-No longer jurisdictional of this section of the project. 4/12/06	-N/A
	-No activities at this time. 4/12/06	-None at this time. 4/12/06	-N/A
Erosion and Sediment Controls Bethel Education Park	-Restoration areas along both portions of the ROW looked good. 4/12/06 -The northern tower area is in good shape. The ruts in the ROW should be revegetated. 4/12/06	-None at this time. 4/12/06 -Restoration efforts in the area continue. 4/12/06	-N/A

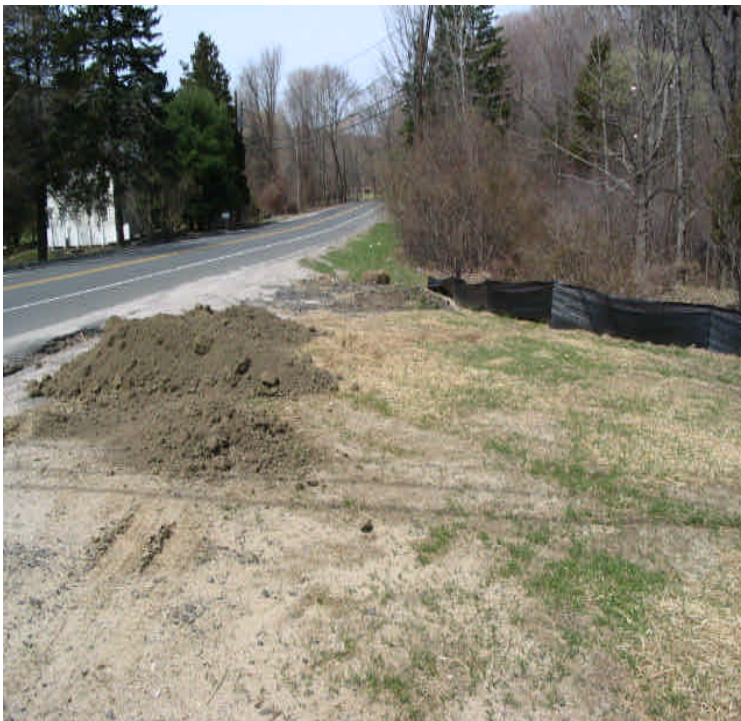
115kV (Sunset Hill): Photo on the left shows where controls continue to be useful due to sediment accumulating against the fence and sparser vegetation. Photo on the right shows grass growth is increasing and controls could be removed shortly. 4/12/06

- The Putnam Park storage area remains in good shape. 4/12/06	- None at this time. 4/12/06	- N/A
	-The Sunset Hill Rd. storage area controls remain in good shape and grass growth continues. 4/12/06	- The controls parallel to Rt. 58 should remain due to potential for sedimentation here but the remaining area is becoming stable. 4/12/06	- N/A (Grass growth continues)
Rt. 107 (Lonetown Rd)	- Widespread restoration efforts and mulching were noted, including a vault near Lois Lane. 4/12/06	-Continue to restore the edge of roadway where necessary. 1/4-4/12/06	- Restoration efforts were noted

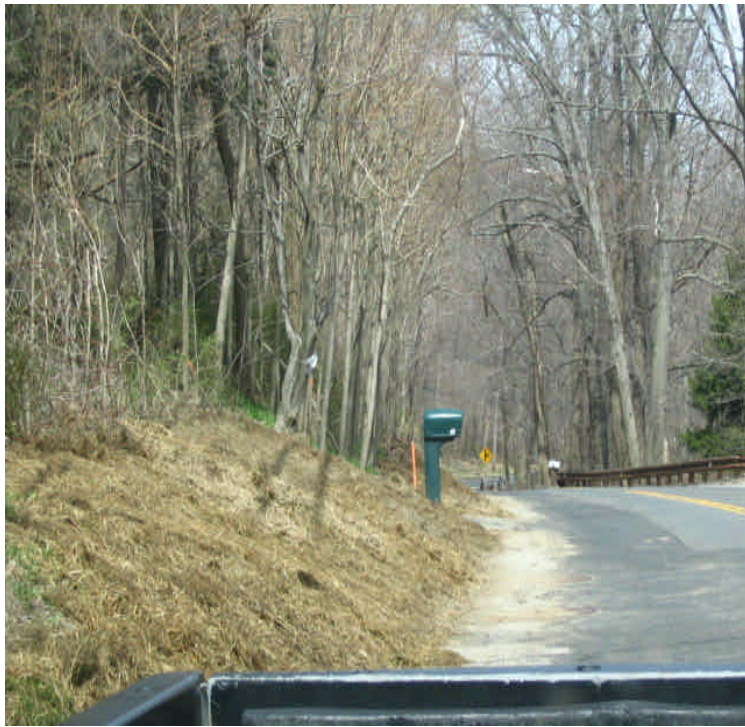
115kV (Rt. 107): Photo on the left shows restoration efforts made at the vault location near Lois Lane. Photo on the right shows the storage area off Rt. 107 where grass growth continues. Controls could also be removed from here shortly. 4/12/06

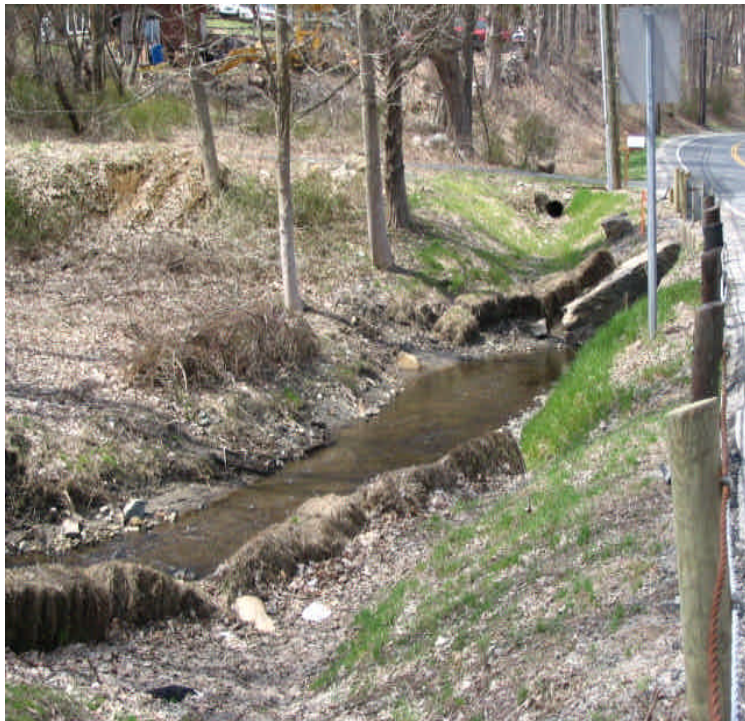
Photo on the left shows the stream at Sara's Way along Rt. 58 which has continued to revegetate. Photo on the right shows some recent roadside restoration in this area. 4/12/06
